Manhole Inspection Summary

Manhole # S29C__009MH

Insp Date: **5/27/09 4:14 PM**

Location Address: **MARTIN LUTHER KING BLVD** Cross Street: **W MULBERRY ST**

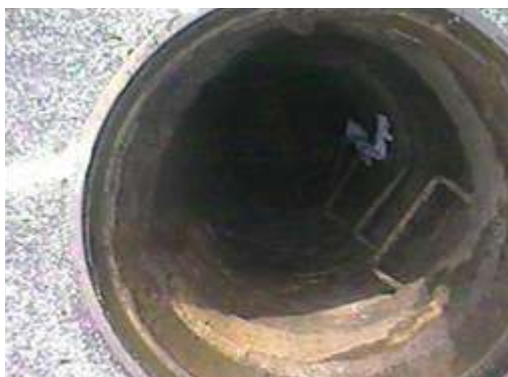
Defect 1

Surcharge ☒ **Evidence Of Surcharge** Depth: **4** (ft.) ☐ Active Surcharge Present

EVIDENCE OF ASUR

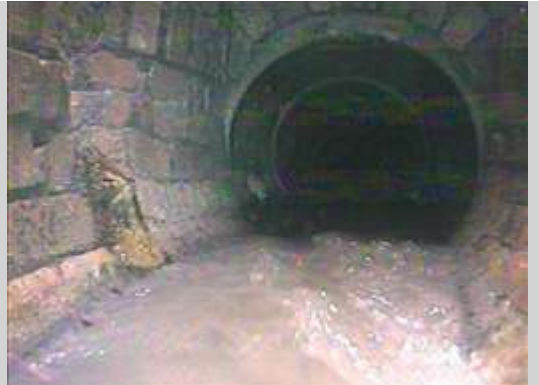
12 O'Clock Outflow

18 in. Circular Gravity Sewer
Pipe Out @ 12 O'Clock

Pipe Height: **14.4** (in.) Rod and Bar
Pipe Material: **Clay** ☐ Pipe Lined
Invert Depth: **15.74** (ft.) Flow Characteristics: **Fast**
Deposits: ☒ None ☐ Mud ☐ Sludge ☐ Debris ☐ Grease
Silt Depth: (in.) Deposits Extent:
Infiltration: **None** Pipe Seal Cond: **Sound**

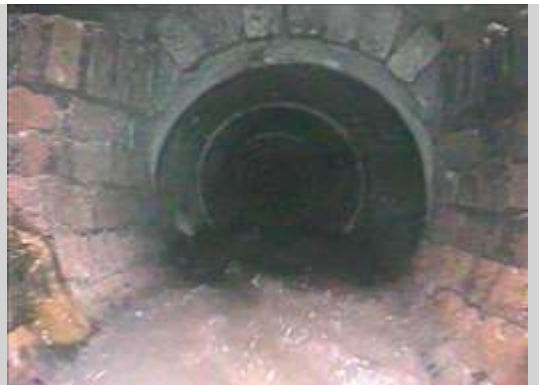
3 O'Clock Inflow

8 in. Circular Gravity Sewer
Pipe In @ 3 O'Clock

Pipe Height: (in.) Direct
Pipe Material: **Clay** ☐ Pipe Lined
Invert Depth: **14.72** (ft.) Flow Characteristics: **Fast**
Deposits: ☒ None ☐ Mud ☐ Sludge ☐ Debris ☐ Grease
Silt Depth: (in.) Deposits Extent:
Infiltration: **None** Pipe Seal Cond: **Sound**

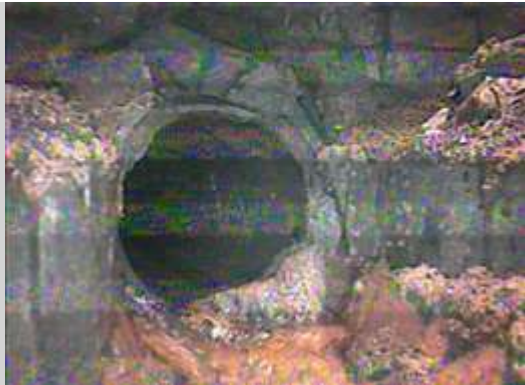
6 O'Clock Inflow

18 in. Circular Gravity Sewer

Pipe In @ 6 O'Clock

Invert Depth: **15.78** (ft.) Flow Characteristics: **Slow**

Infiltration: **None** Pipe Seal Cond: **Sound**

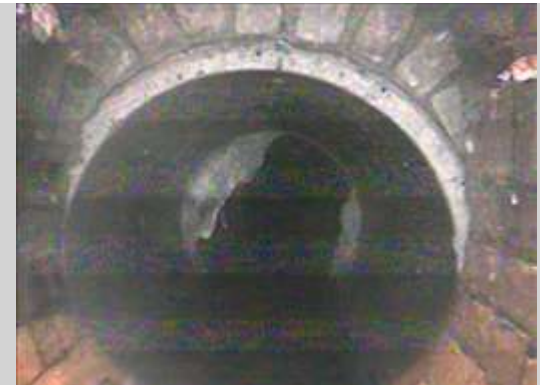
9 O'Clock Inflow

8 in. Circular Gravity Sewer

Pipe In @ 9 O'Clock

Invert Depth: **15.72** (ft.) Flow Characteristics: **Slow**

Infiltration: **None** Pipe Seal Cond: **Sound**
